### **Reconnaissance RSR Meeting**

Lessons learned from Hurricane Otis

### **Hurricane Otis Post-Disaster Assessment**

## 2021 Marshall Fire, Colorado: Field **Reconnaissance Overview NSF NHERI GSC RSR Meeting** 17 Jan. 2025

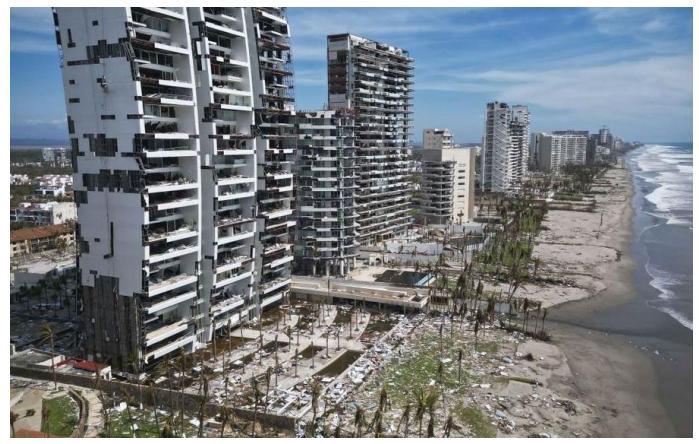
PVRR damage photos & questions to define strategy

- 1. No access to buildings
- 2. Systematic failures to building envelopes

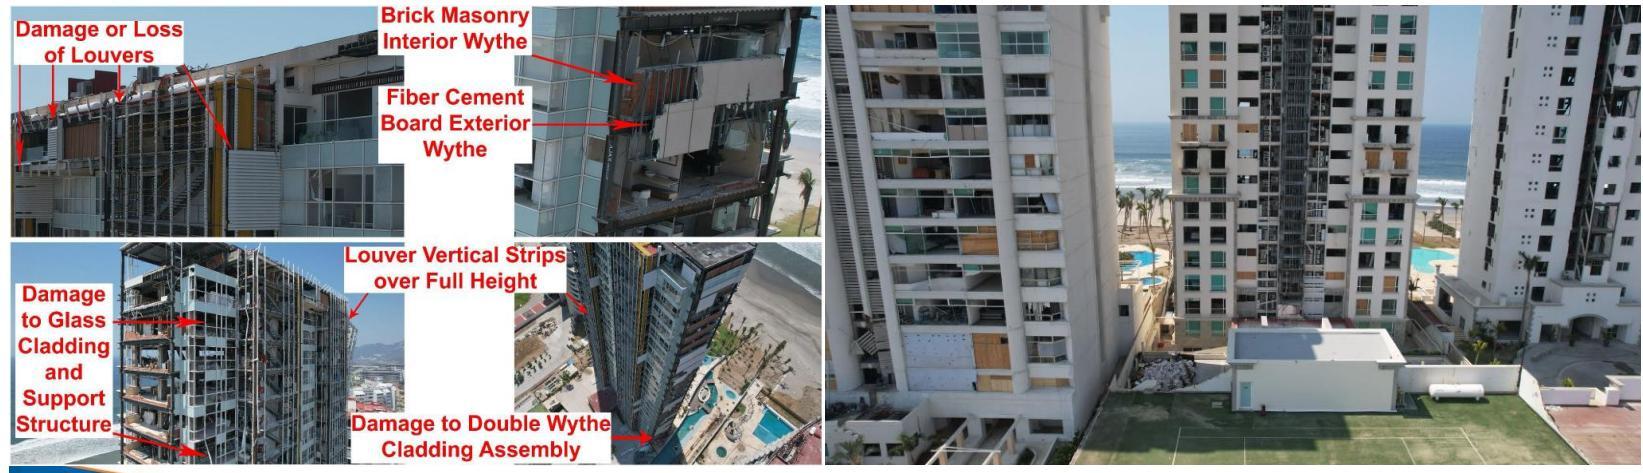
### **Key Observations High Rise Buildings**

- Most assessed buildings were in the high-end architecture market sector (ambitious views) and combined the use of veneer walls, curtain walls, and infill walls as their wall cladding system.
- Lattice metallic panels, louvers, and cement board veneers were implemented as ventilated facades and enclosures of utilities shaft.
- These were all systematically damaged, regardless of the element type.

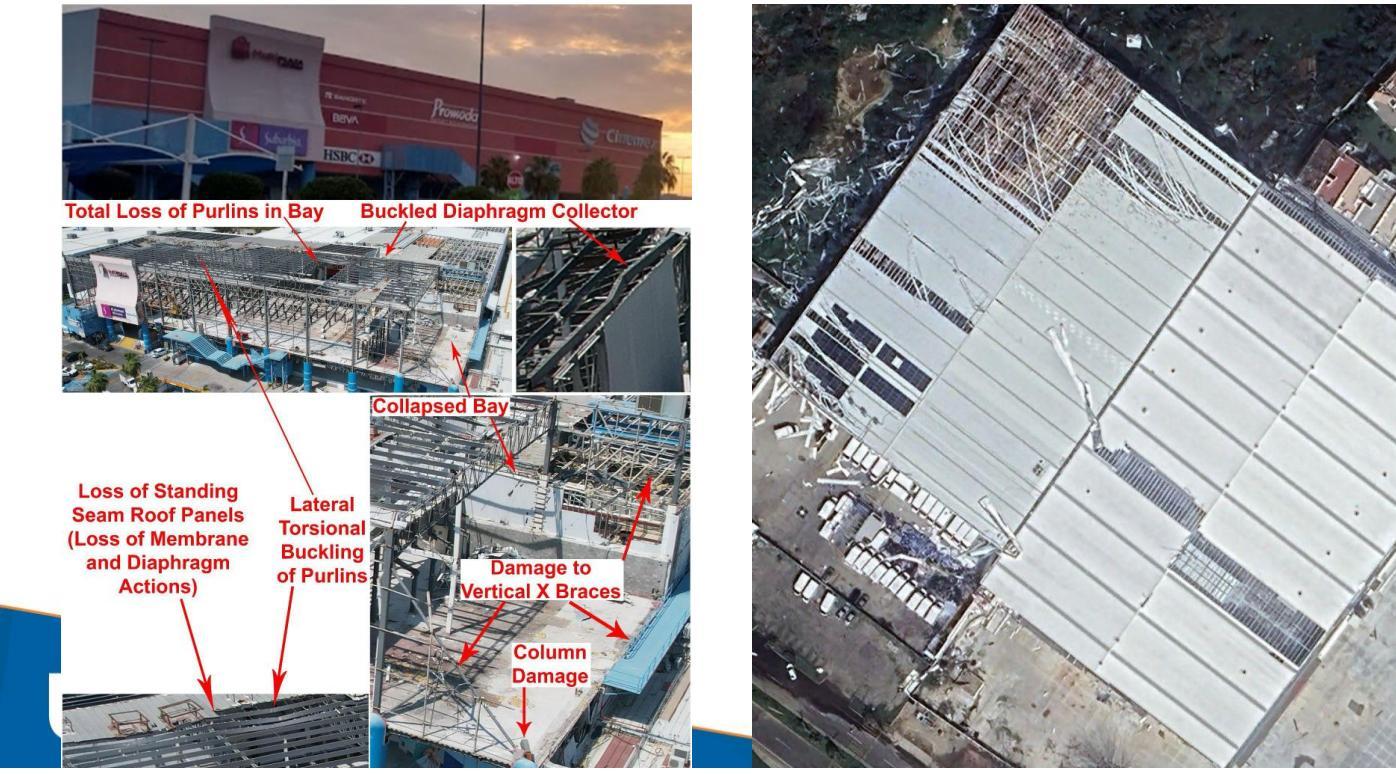
### **Key Observations Low Rise Commercial Buildings**

Car dealerships, wholesale stores (e.g., WalMart, HomeDepot), distribution centers, and other lightweight steel buildings sustained heavy damaged to their building envelope and MWFRS

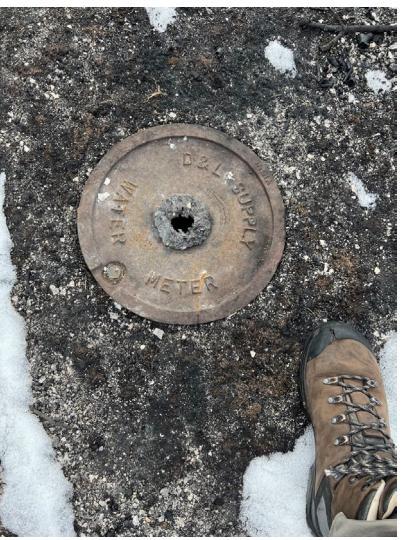
## Fire Impacts on Water **Distribution Infrastructure**

- Burning homes **release chemicals**, like benzene. They also act as a fuel source, heating **service** lines beneath the ground.
- Increased water usage during a fire creates decompression and backflow in waterlines.
- Vacuum draws these chemicals into the pipelines. Service lines are heated/damaged.
- Contaminants may absorb into or adsorb onto pipe. Damaged service lines will need to be replaced.

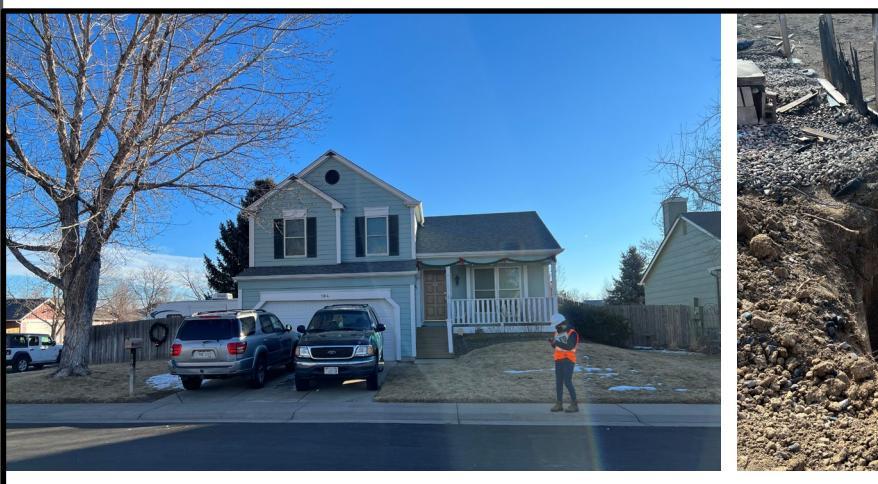
No protection on vents

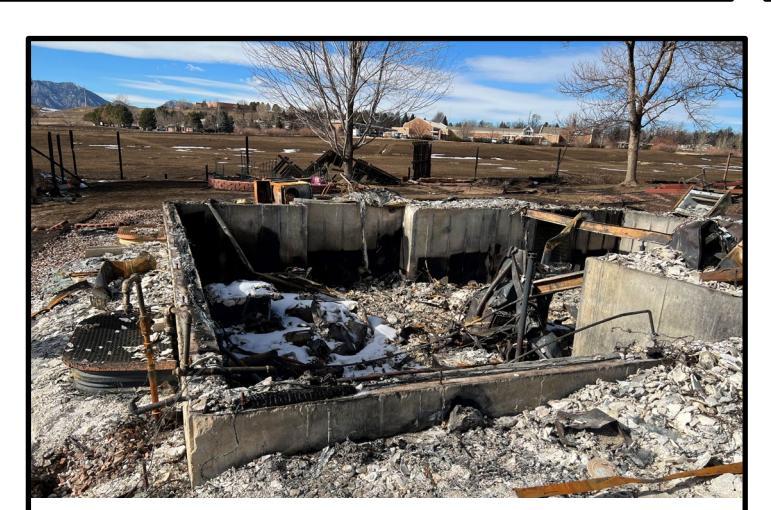
Fences touching homes/Burnt fences
