### **Reconnaissance RSR Meeting**

Lessons learned from Hurricane Otis

### **Hurricane Otis Post-Disaster Assessment**

## 2021 Marshall Fire, Colorado: Field **Reconnaissance Overview NSF NHERI GSC RSR Meeting** 17 Jan. 2025

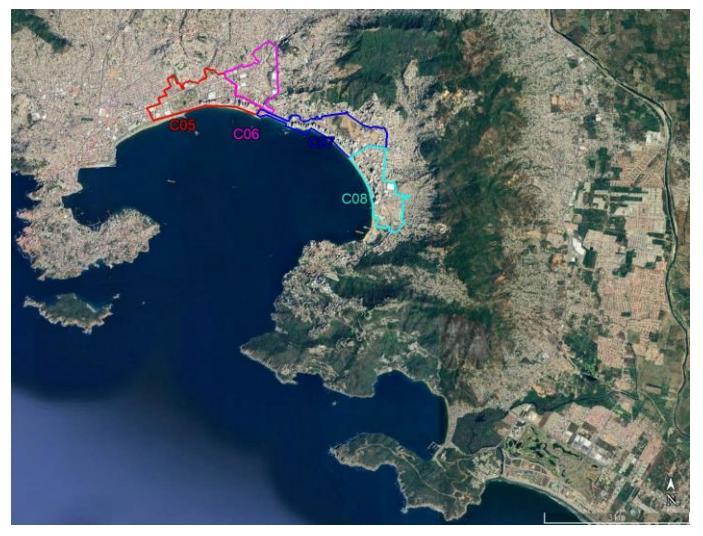
Main Acapulco Bay (day 1 prior to teacher union strikes)

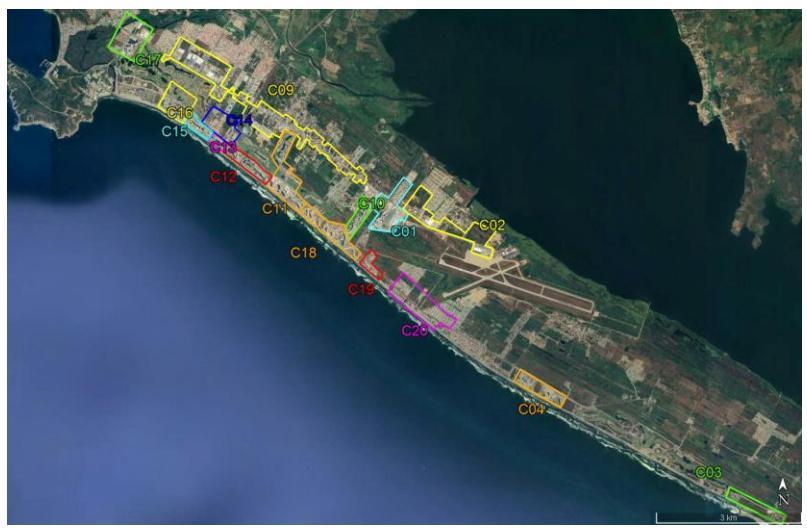
Playa Diamante (days 2 & 3, safer feeling)

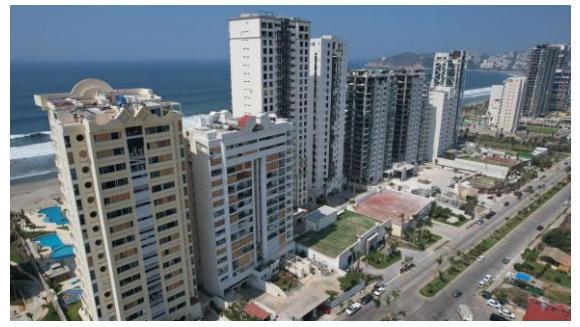
#### UAS Higher Flight Survey of Building Cluster

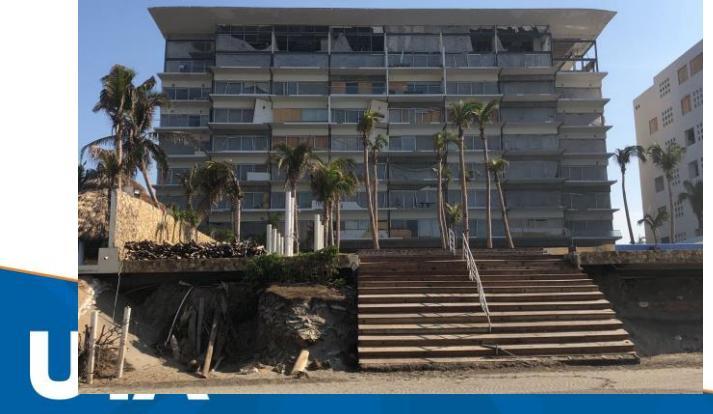
Cell Phone Photographs from Ground & Fulcrum App

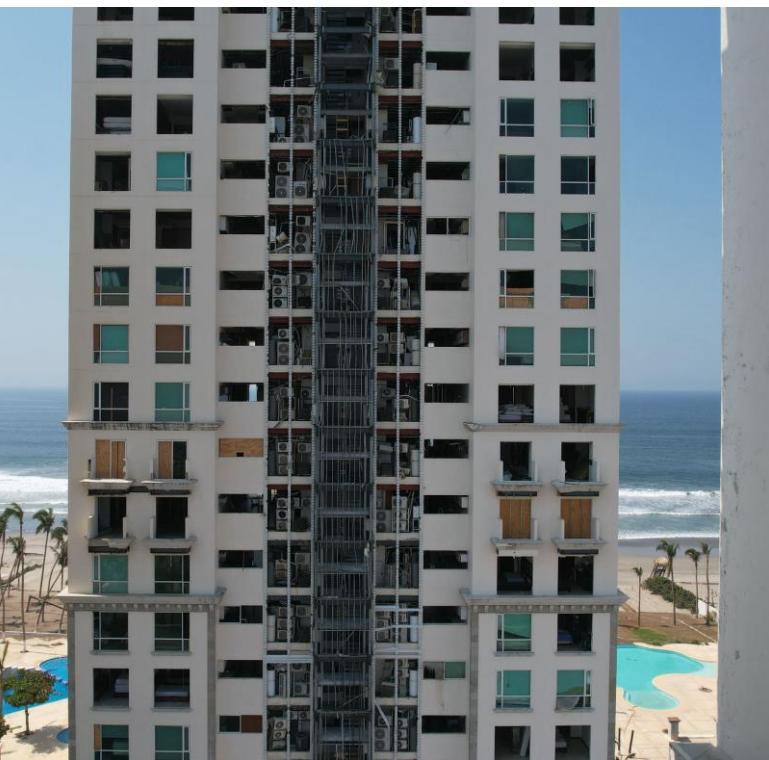
#### UAS Panoramas Wrapping Vertically Up Select Buildings

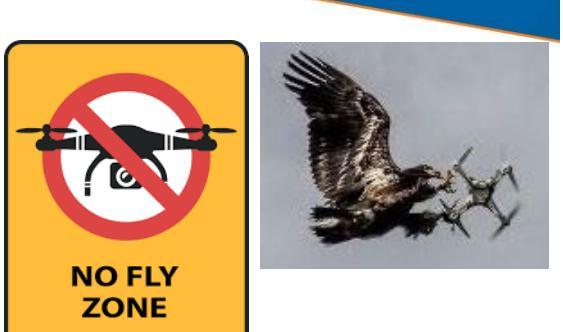
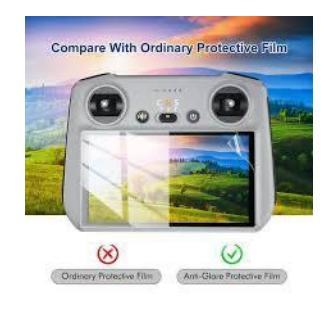
- Signal Interference and Limited Access Points: Widely spaced beach access points and building interference with the drone's line of sight disrupted control, complicating efforts to survey all four elevations in a single operation (we had to survey several buildings from the street first and then from the beach; could have brought more drones)

- Traffic Hazards in the Main Acapulco Bay

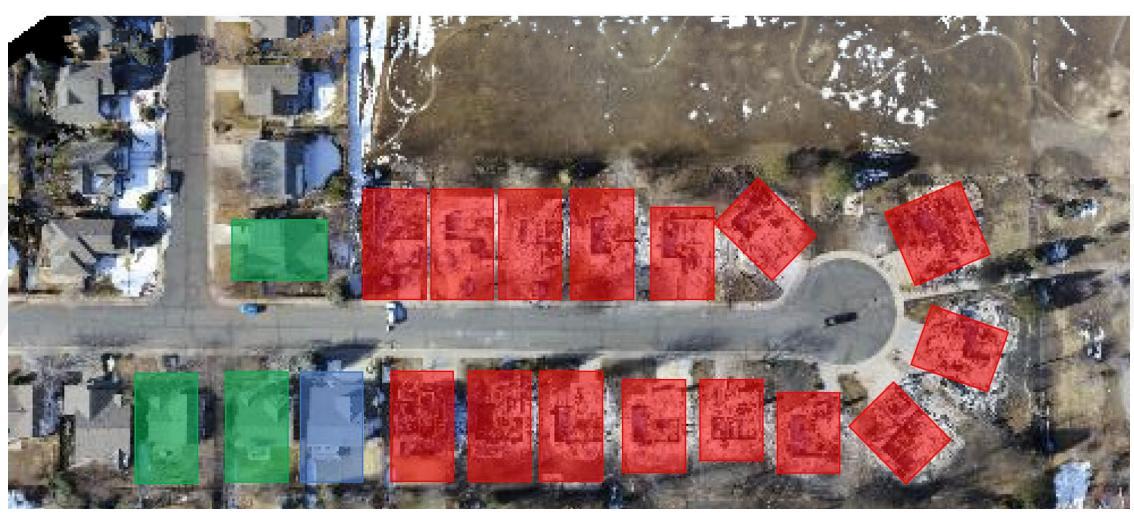
### Damage state of homes

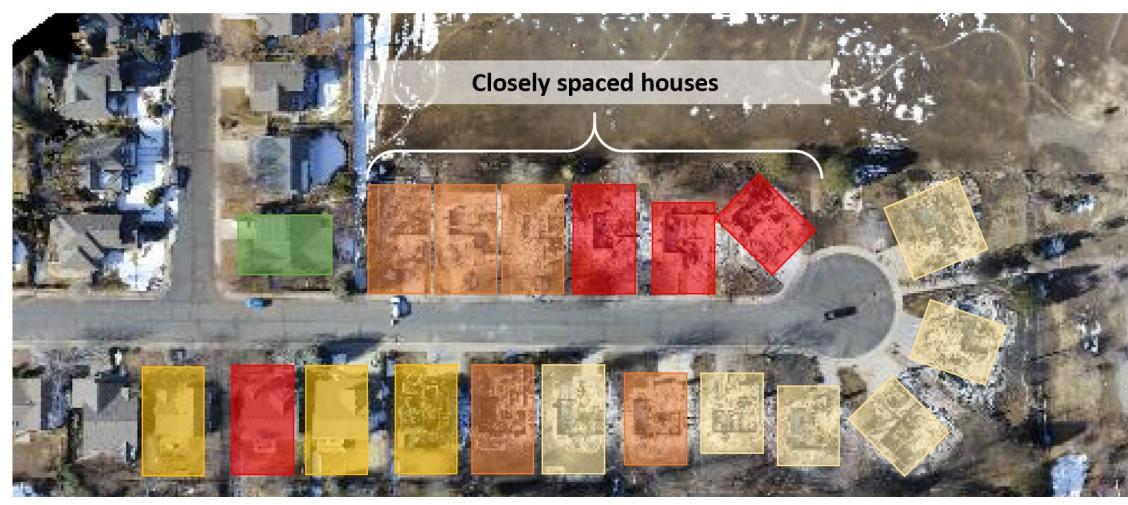
### Proximity of homes to one another

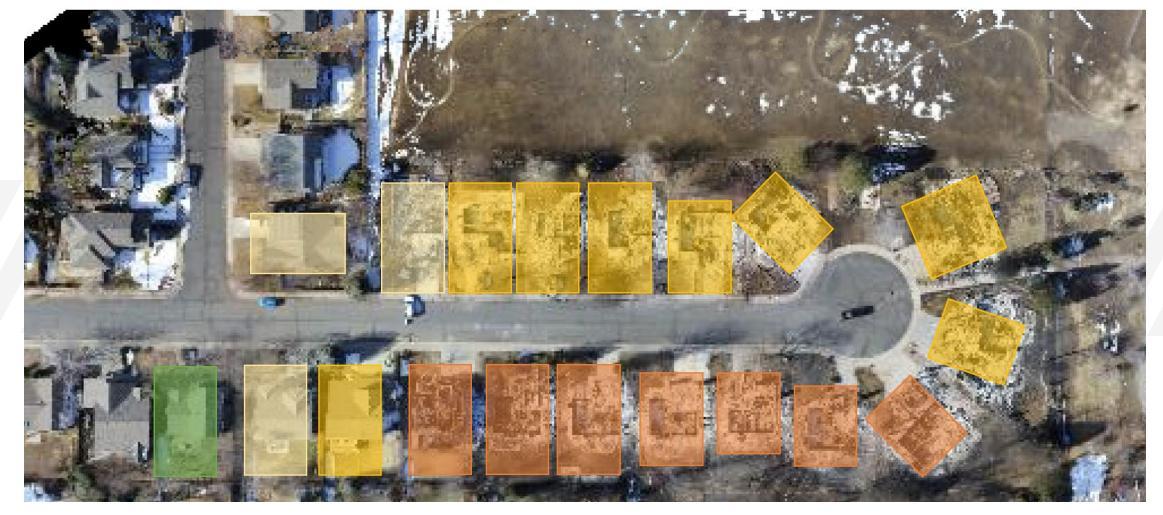
### Proximity of homes to other damaged homes

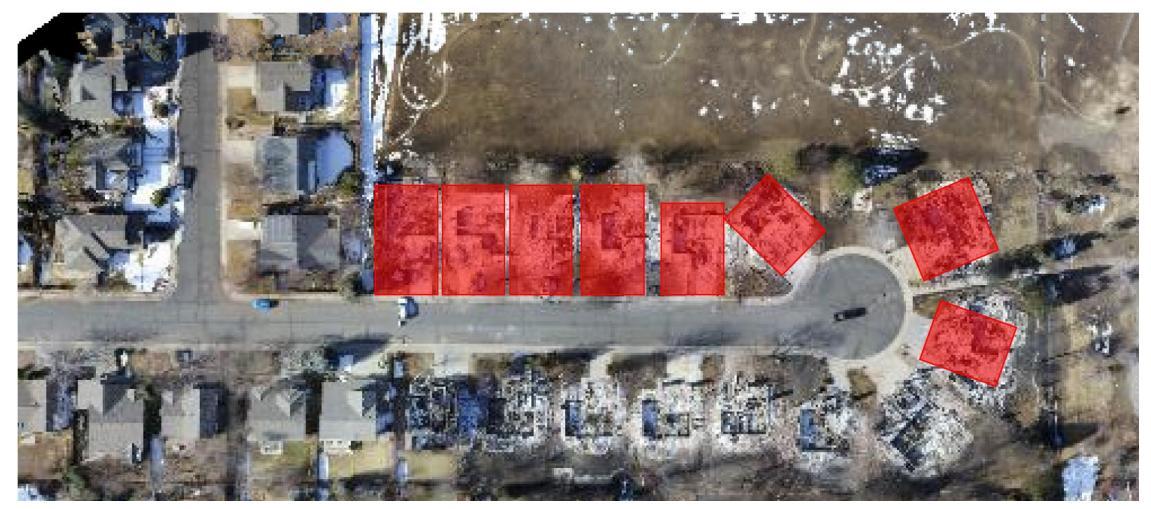
### Proximity of homes to open space

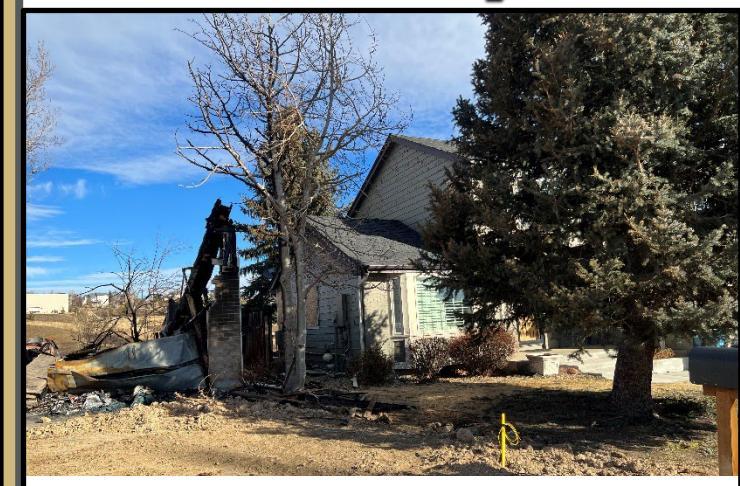
### **Closely spaced houses**

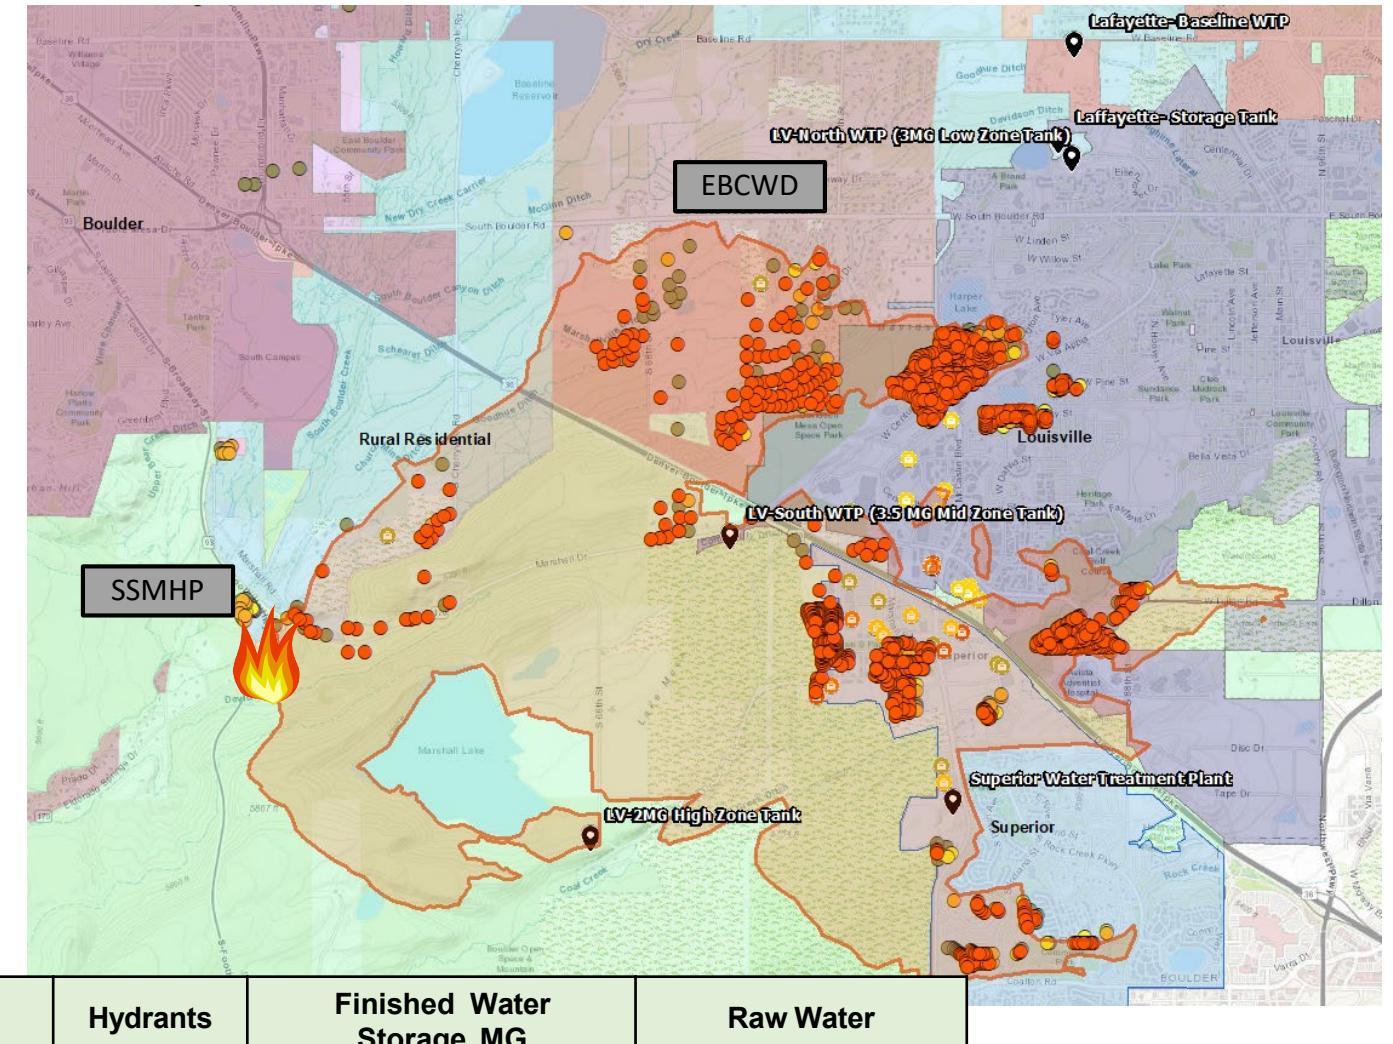
### **<u>5</u>** Public water systems were damaged affecting about 60,000 people

Public Water System (pop.)	Damaged/Destroyed Properties	Water Mains, miles	Hydrants	Finished Water Storage, MG	Raw Water	
Louisville (20,319)	593 of 7,339	120	1,200	7.5	Surface water	
Superior (17,170)	436 of tbd	50	430	3.4	Surface water	Eldorado Artesian
Lafayette (28,700)	22 of 9,700	177	900	14	Surface water	Spring: 2 wolls
EBCWD (300)	72 of 137	8	40	0.1	Lafayette	Spring. 2 wens,
S.S. Mobile Home Park (150)	3 of 61, wind	<1	None	None	1 Well	one spring

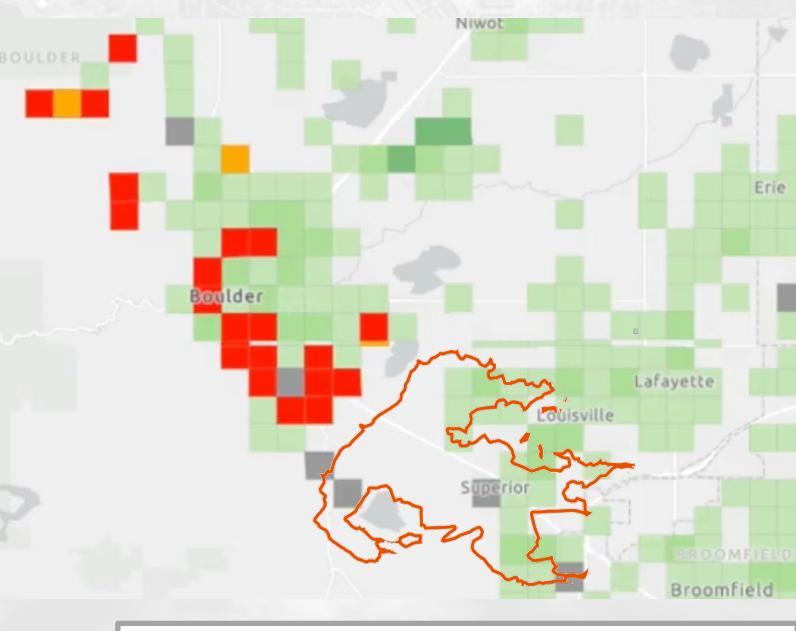
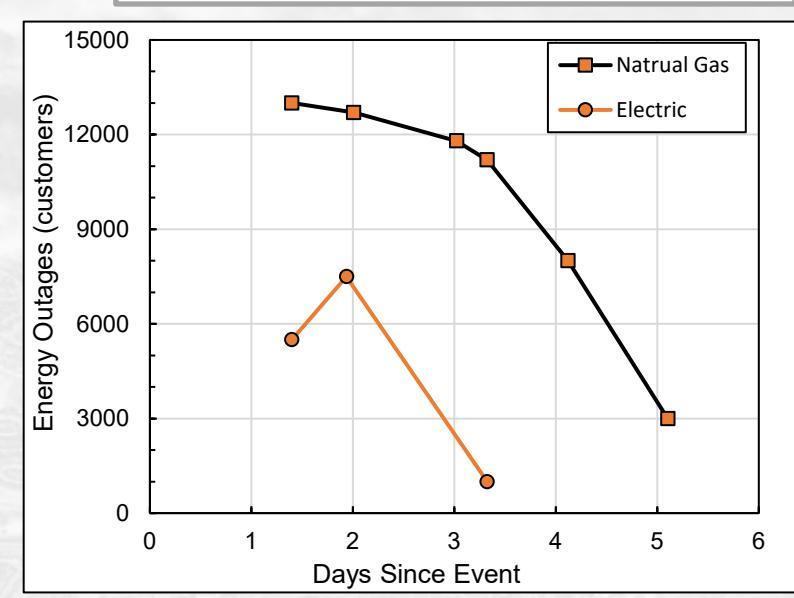
- Natural Gas
  - 13,000 customers with out gas
  - Xcel Energy dispatched 500 employees to help and provided thousands of portable heaters (freezing temperatures)
  - 6 Jan., most customer restored
- Electric
  - Statewide- 100,000 customers lost power (high winds impacted before fire)
  - Day after the fire, more than 5,500 without electricity
  - 3:52 PM- power our at evacuation center, facility relocated
  - 3 Jan. (4 days post fire) electric restoration "nearly complete"
- **Telecommunications** 
  - Xfinity- 8% of customers without connection one week after fire
- Wastewater- treatment challenges
- Transportation- evacuations, supplies notice
